End of Panel Report

December 2011

**Illawarra Coal Environmental Field
Team**

West Cliff Mine Longwall 34

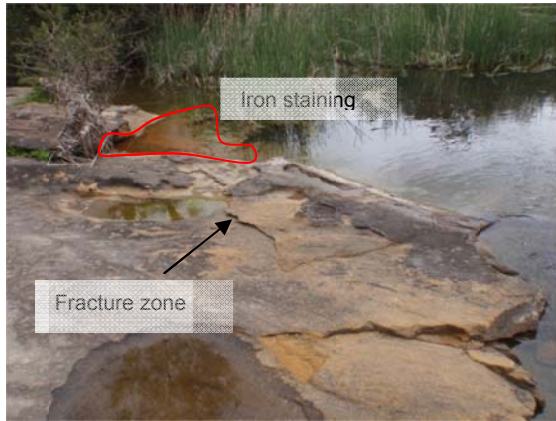
A zone of fracturing was identified on the western margin of Rockbar 41. The fractured zone extends over an area of approximately 2m² and consists of multiple small fractures and uplift of 1cm along the fractured zone (Figure 4 and Figure 5). The fractured zone is situated on the edge of the dominant flow path and will be under water during periods of moderate to high flow in the River. No flow diversion was observed during the inspection. The water level in Pool 41, immediately upstream of the fractured rockbar is consistent with baseline levels.

Figure 4: Zone of fracturing and iron staining.

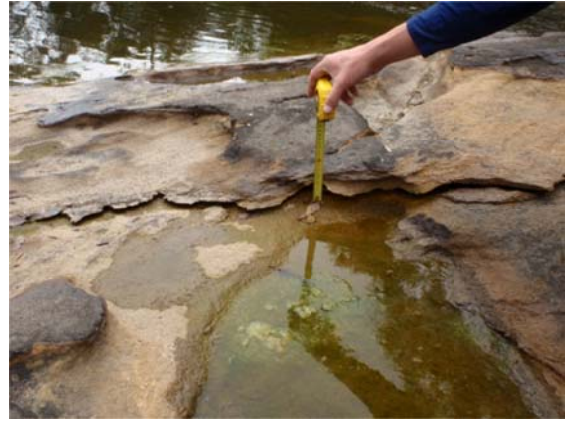
Figure 5: Rock fracture and uplift.

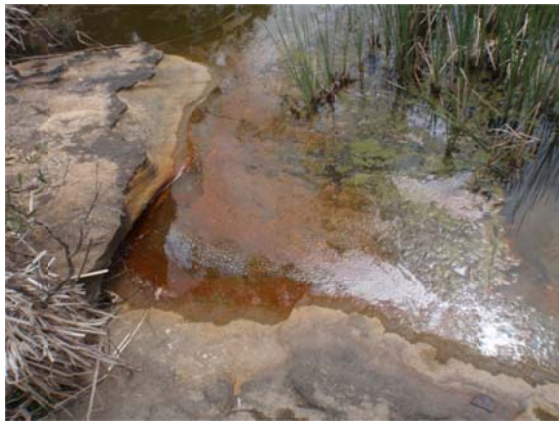
Iron staining was identified in Pool 40d situated on Rockbar 41 (Figure 6). The staining is localised to the western margin of the pool and no iron staining is visible downstream in Pool 40b.

Figure 6: Iron staining.

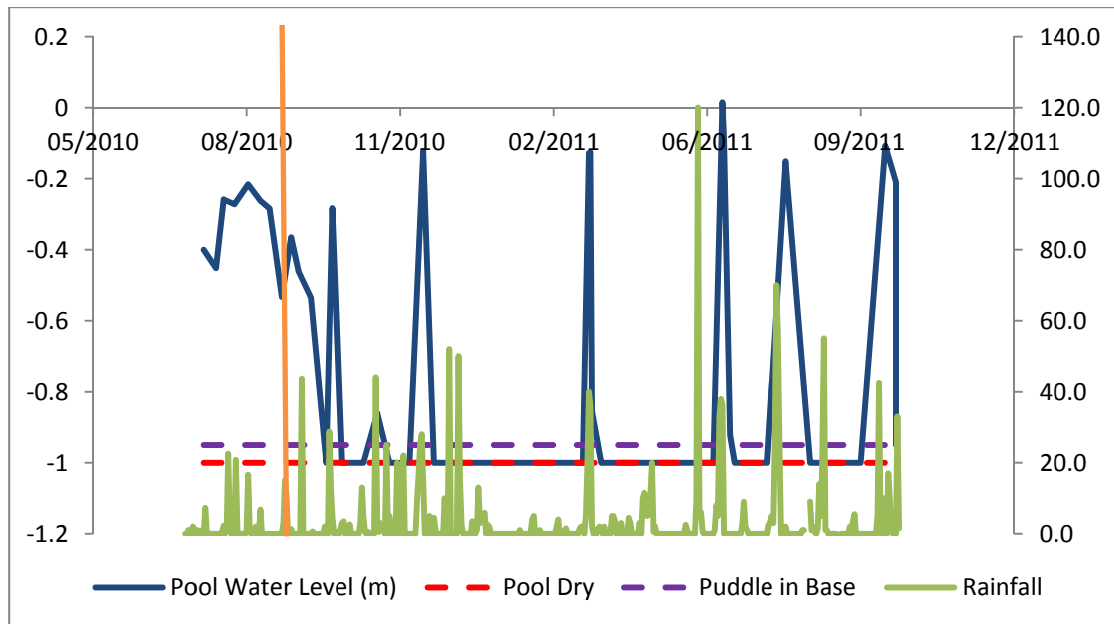
Minor compression fracturing and surface flow diversion was observed within Mallaty Creek at monitoring site Pool MC 109. This has resulted in localised reduction in pool water level (Figure 4, Figure 5 & Figure 6). A small number of minor compression fractures were observed in pool MC109 with a maximum width of 3mm and up to 220mm in length. The immediate upstream and downstream monitoring pools, MC108 and MC110 respectively, continue to retain water. Pool MC109 water levels continue to respond to recharge rainfall events.

Figure 7: Pool water level – MC109. MC109 was undermined on the 4 September 2010 (indicated by the orange line). Rainfall data collected from West Cliff Mine.

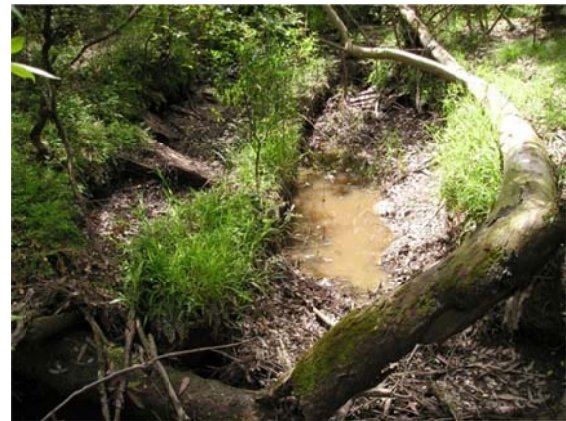
Figure 9: MC109 with reduced pool water level

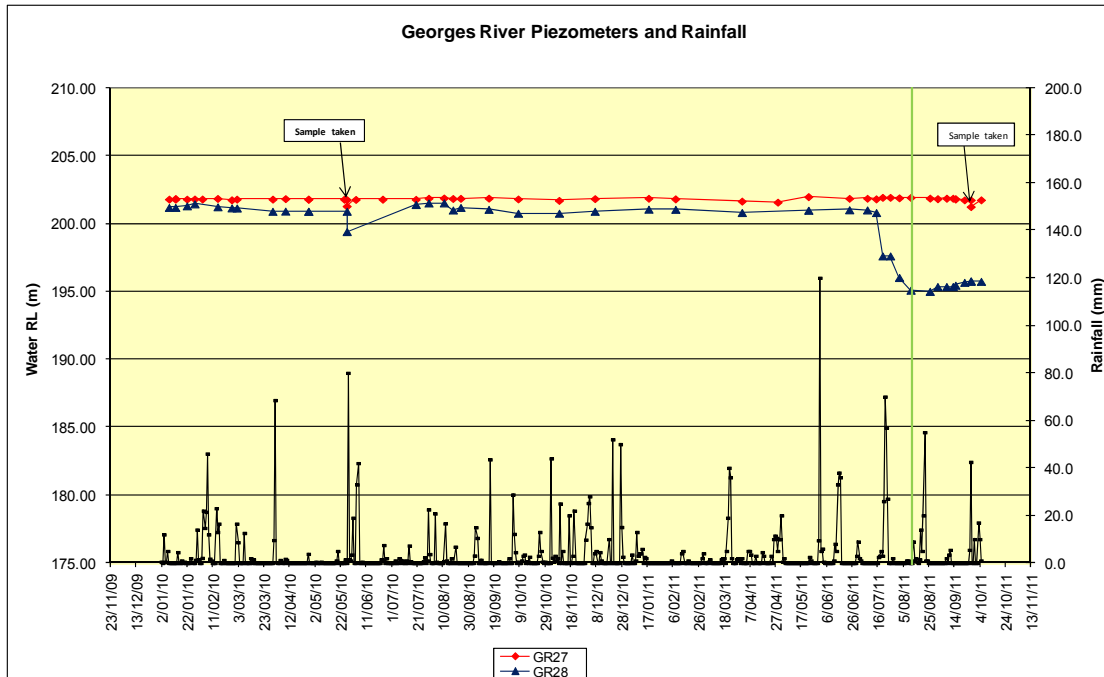
Borehole GR27 water levels have remained relatively stable with no water level reduction associated with Longwall 34 extraction (**Error! Reference source not found.**). Borehole GR28 recorded a temporary decrease in water level toward the end of Longwall 34 extraction. Since the initial reduction in water levels in GR28 the water level has responded to recharge rainfall events. Water level rises were recorded after rain events on 25 and 26 September 2011 and 3 October 2011 (**Error! Reference source not found.**).

Figure 11 shows the correlation between water levels in boreholes GR27 and GR28 and rainfall. Water samples were taken from both boreholes on two occasions - 27 May 2010 and the 27 Sept 2011. This resulted in minor decreases in water level as shown in the figure below.

Figure 11: Water Level in Georges River Groundwater Boreholes and Rainfall.

GR28 was undermined on the 12 August 2011 (indicated by the green line). Rainfall data is from West Cliff Mine.

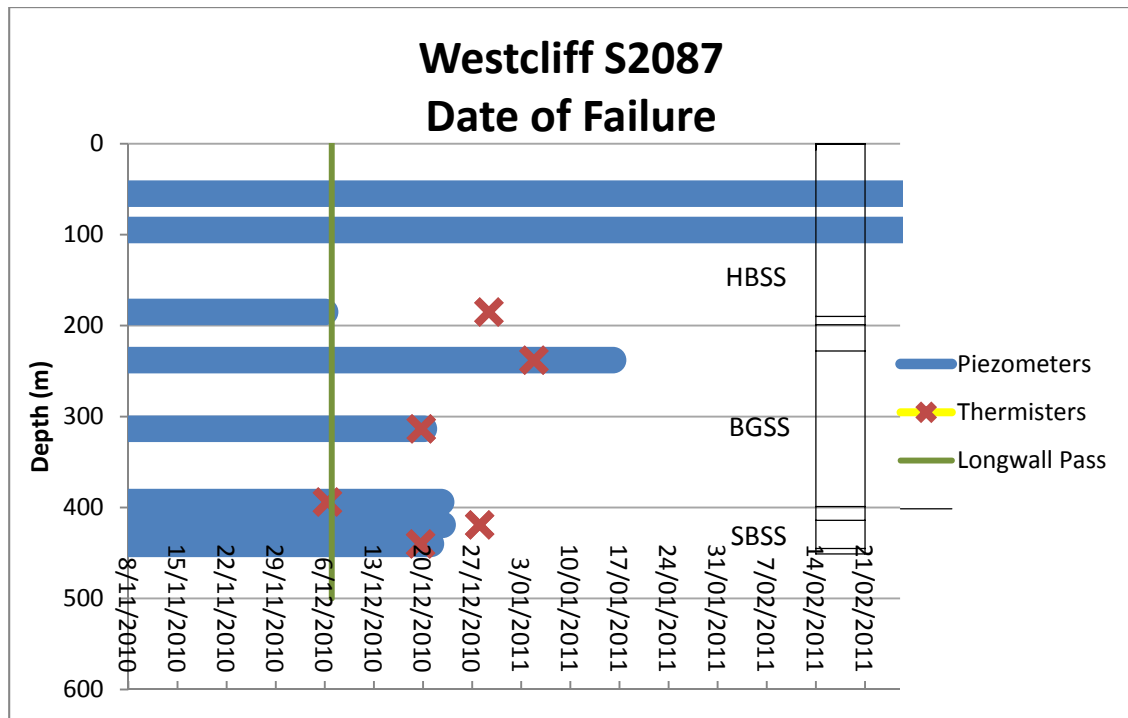
Longwall 34 passed close to the location of this bore on 7 December 2010. All except the two uppermost piezometers failed in a seven week period subsequent to 7 December 2010 (Figure 12). This was probably as a result of strata shear from mine subsidence movements. This was an expected outcome based on the location of the bore in relation to the longwall.

Figure 12: Failure dates of the six deep groundwater piezometers located within Borehole S2087.

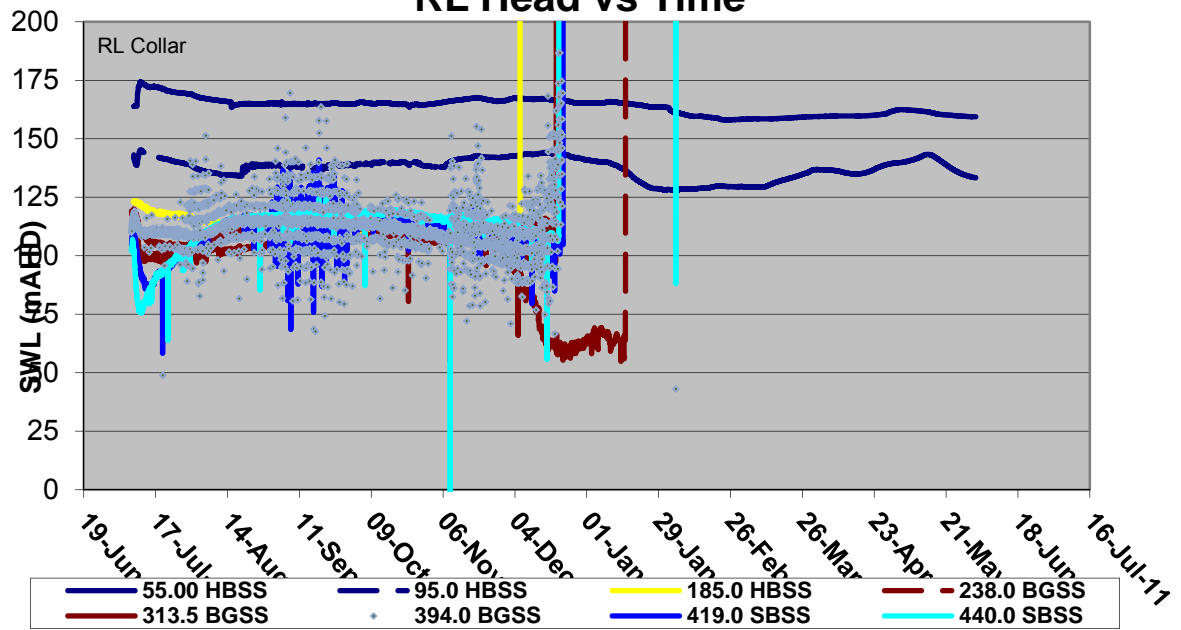
Quality of the piezometric data acquired over the recording period was poor to good. The deeper piezometers were affected by electronic noise which did respond to site adjustments but was not completely eliminated. The data shows a period of two months of stabilisation extending to September 2010. After September 2010 the Narrabeen piezometers show a slow fall in piezometric head until December when the piezometer at 238m shows a marked drop in piezometric head until its failure about ten days after the passing of the longwall. The remaining five piezometers that failed in the Narrabeen and basal Hawkesbury Sandstone did not show any significant fall in piezometric head prior to their failure shortly after the passing of Longwall 34.

Two piezometers at 55 and 95m in the Hawkesbury Sandstone remain operational into 2011. The relative head level of each of these piezometers is greater than the six lower piezometers which commonly showed a relative level of the order of 100m to 115m (Figure 13). The two upper piezometers are more variable in their head with time but do not appear to show more than a coincidental relationship with the passing of Longwall 34. The variation in heads in both these piezometers would appear to be influenced by seasonal rain levels and intensity.

Figure 13: Deep and shallow groundwater level data from piezometers located within Borehole S2087.
