**RE: ABORIGINAL AND EUROPEAN HERITAGE ASSESSMENT FOR WEST CLIFF COLLIERY - LONGWALL
34 END OF PANEL REPORT**

Background and Introduction

Niche Environment and Heritage was commissioned by BHP Billiton Illawarra Coal (BHPBIC) to conduct an End of Panel (EoP) assessment of the European and Aboriginal cultural heritage and archaeological sites within the limit of subsidence of Longwall 34 at West Cliff Colliery.

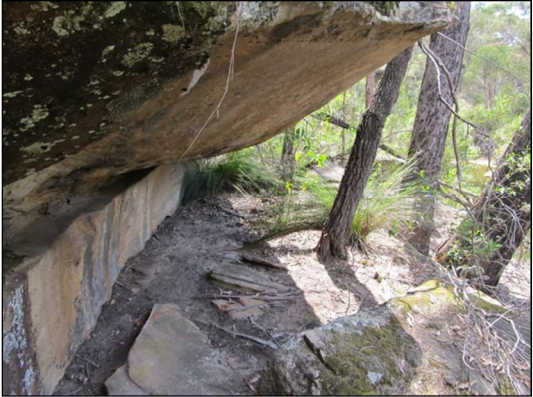
| AHIMS site number | Site Name | Results of inspection | Photograph of current condition of site |
|---|---|--|--|
| 52-2-2234 | Georges River 1 | Shelter in same condition as previously described in Biosis Research 2007. There has been further natural weathering to the art panel, which has caused further granular loss, and white leeching process has occurred over the infill kangaroo. | <p data-bbox="826 824 1070 853">Northern view of the shelter</p> |

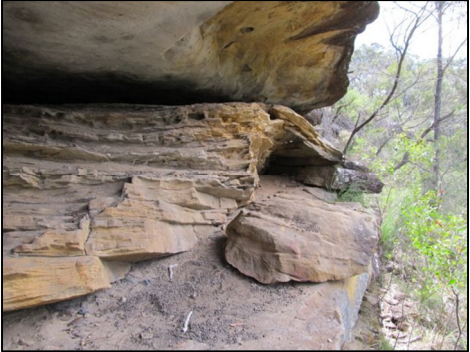
| AHIMS site number | Site Name | Results of inspection | Photograph of current condition of site |
|---|---|--|--|
| 52-2-2243 | Georges River 3 | Shelter and Art is in the same condition as described in Biosis Research 2007. A number of artefacts were relocated in the shelters drip line. | <p data-bbox="826 1240 1031 1270">Northern end of shelter</p> |

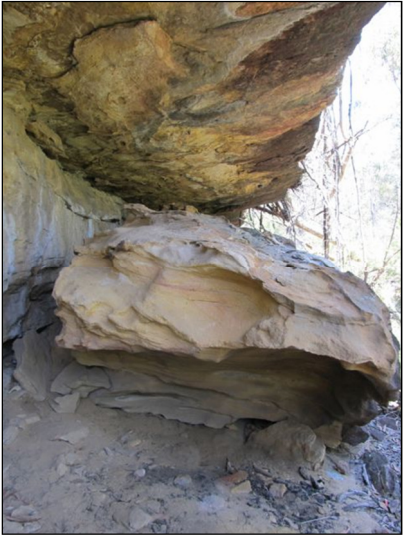
| AHIMS site number | Site Name | Results of inspection | Photograph of current condition of site |
|---|---|--|--|
| 52-2-2241 | Georges River 5 | Shelter and Art are in the same condition as described by Biosis Research 2007; there were a number of broken modern glass fragments located on the top of the large block (pictured) located at the front of the site that had not previously been noted. The single quartz artefact was relocated in the shelters drip line. | <p data-bbox="826 1839 1067 1868">Southern end of the shelter</p> |

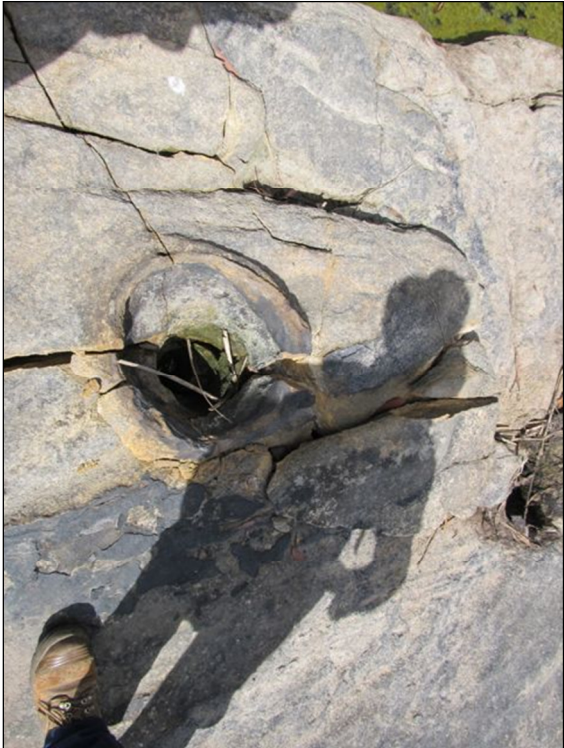
| Site Name | Results of inspection | Photograph of current condition of site |
|--|---|---|
| WH 1- Historic Bridge and Road remains | Cracking has been previously reported in relation to Longwall 33 (Biosis 2010). There has been no further damage to this site as a result of Longwall 34. | |

No additional cracking to the European Heritage site WH1 above that which was reported in relation to Longwall 33 (Biosis 2010) was observed by Niche Environment and Heritage. Other European Heritage sites were not assessed due to access restrictions, and for reasons outlined above they are of little concern in relation to Longwall 34.

| Level | Characteristics of level | Actions & Notifications | LW 34 Impacts | Actions as a result of LW 34 |
|---|---|--|--|--|
| Within Predictions (Minor Impacts) | <ul style="list-style-type: none"> • Change in site conditions not attributable to natural weathering or preservation – (as observed by comparing pre-mining photographs with post-subsidence/mining photographs). | <ul style="list-style-type: none"> • Continue with monitoring program. • Condition assessment and photographic record completed. • Summarise all actions in Subsidence Management Status and Impact reports, as well as monitoring results in End of Panel Reports and AEMRs. • Inform stakeholders of baseline assessment • Notify agencies of impacts in monthly subsidence report | There has been some cracking at heritage site WH1, which was noted by Biosis research (2010) in the End of Panel Report for Longwall 33. There have been no further impacts to WH1 due to the extraction of longwall 34. | BHPBIC should continue to monitor the site in accordance with the approved monitoring program. |
