Appin Longwall 703

End of Panel Report: Aquatic Ecology

Job Number: EL1011071

Prepared for BHP Billiton Illawarra Coal

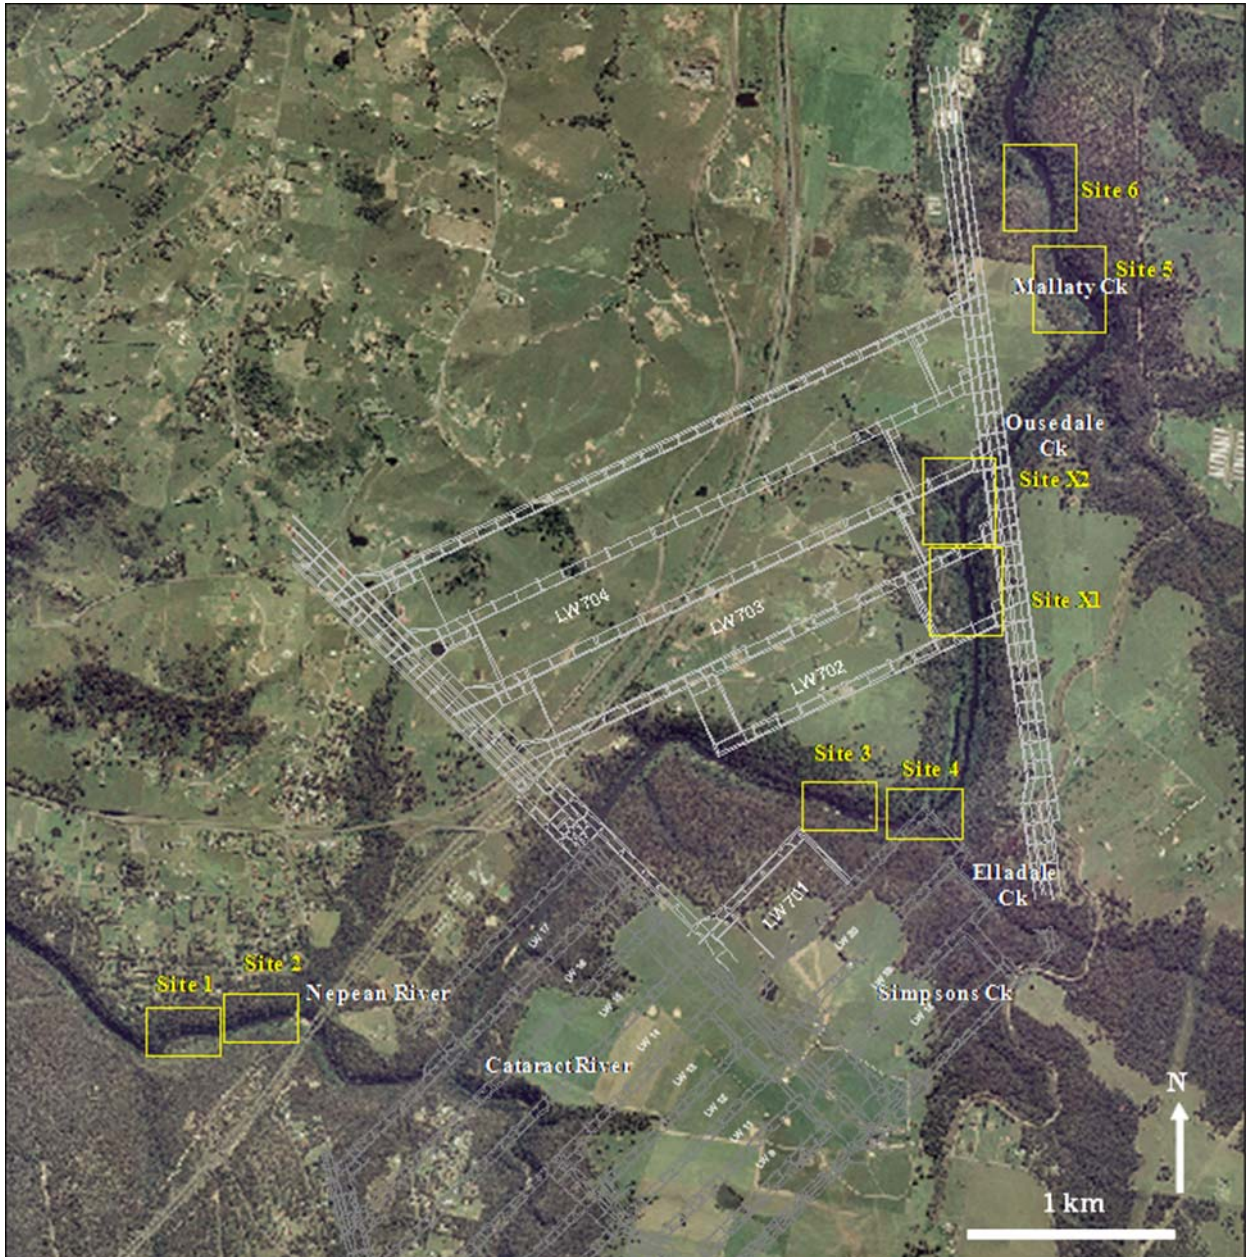
Figure 1: Aerial photo of the study area showing aquatic ecology monitoring sites in and around the Nepean River relative to Appin Longwalls 701-704.

The baseline and during-extraction monitoring of aquatic ecology undertaken at sites relevant to LW703 in the Appin and Douglas Park areas are summarised in Table 2. Preliminary baseline monitoring for Longwalls 701-704 was undertaken by The Ecology Lab in September 2003 and 2005 (The Ecology Lab 2004; 2006). The findings from these reports were incorporated into the monitoring programme proposed in the SMP and further baseline data relevant to LW703 was collected by Cardno Ecology Lab during 2008 and 2009 (see Table 2). The sites incorporated into the monitoring programme included upstream (1 and 3) and downstream (5 and 6) control sites relevant to Longwalls 701-704 and 705-710, and potential impact sites for Longwall 701 (3 and 4) and Longwalls 702-704 (X1 and X2) (Figure 1).
