Dendrobium Coal Mine - Area 3A

Aboriginal Heritage Plan

Report for BHP Billiton Illawarra Coal

April 2010

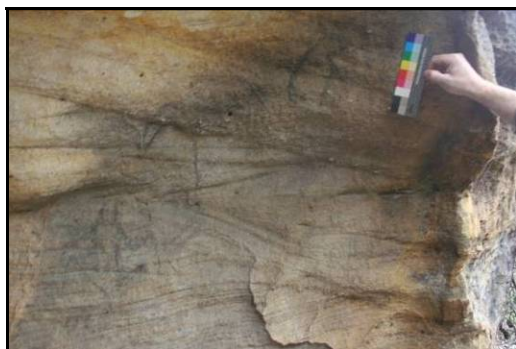
Plate 1: Charcoal motifs on 52-2-0458 shelter surface.

The original recording of the site noted 6 charcoal outline indeterminate motifs on three separate panels. The recent survey identified only two panels; both contains the charcoal motifs previously recorded (Plate 1). The third panel could not be relocated. The current survey recorded a fourth panel 2.0 m x 3.0m of red ochre and potential infill of indeterminate features (Plate 2).

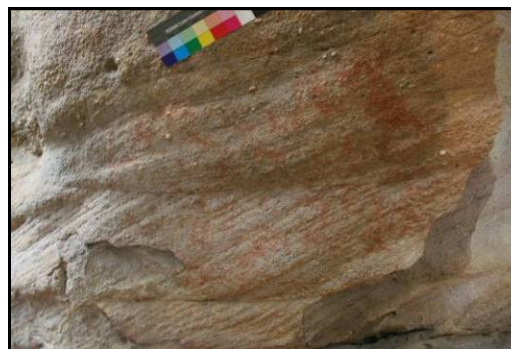
Plate 2: Indistinguishable red ochre motifs on 52-2-0458 shelter surface.

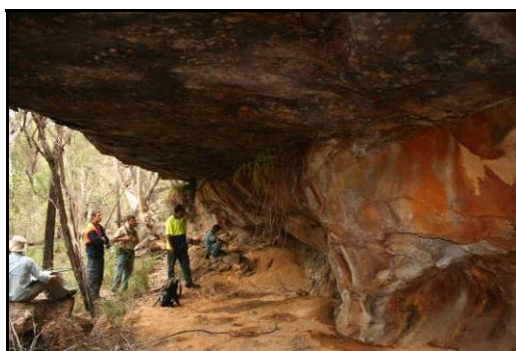
Plate 3: sandstone overhang and archaeological deposit, site 52-2-1646 **Plate 4:** Charcoal fish motifs site 52-2-1646.

This art shelter site is located 200 m south east of the junction of the 8th eastern tributary of Wongawilli Creek. The site is under the second top ledge. The sandstone overhang measures 18 m x 4 m x 2.8 m in size and the living area is 8 m x 2 m (Plate 3). The site was formed by block fall and cavernous weathering. The floor deposit is yellow orange loamy sand up to 10 cm deep, although most of the floor is rocky and the deposit is less than 5 cm deep. The rear wall contains: 10 red ochre hand imprints which included 5 right hands and 2 left hands ranging in size from small to large; 1 red ochre child's left hand stencil; 1 red ochre adult hand stencil; 1 child red ochre hand stencil; 1 charcoal outline kangaroo; 1 charcoal outline bat; 3 charcoal outline possums in a frieze; 5 charcoal indeterminates; 2 charcoal outline and infill indeterminates; 2 charcoal outline frontal human figures; 1 charcoal outline and infill kangaroo and 2 charcoal outline fishes (Plate 4).

The art is in good condition. The shelter has water seepage over the lip of shelter and heavy water down the face of the shelter, across the roof and at the centre of the shelter. Ferns, moss and white mould is growing on the surfaces of the shelter. The shelter is suffering continued cavernous weathering and exfoliation.

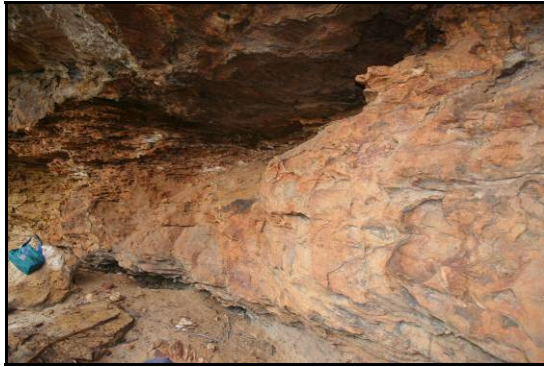
Plate 5: interior of artefact and shelter site 52-2-1647. **Plate 6:** artefacts from site 52-2-1647.

This artefact shelter site is located in a large sandstone overhang located on the top ridgeline at the end of a point above Wongawilli Creek. The sandstone overhang measures 10 x 4 x 4 m in size and the living area is 8 x 4 m. The floor deposit is red cream sand 10 cm deep. The floor also has block and smaller sandstone rocks that have fallen from the roof (Plate 5). There is no artwork within this shelter but a number of artefacts have been located. The artefacts include a complete basalt flake, a complete quartz flake, a quartz core and an agate core (Plate 6).

The site is in good condition. The shelter is cavernously weathered but is very dry.

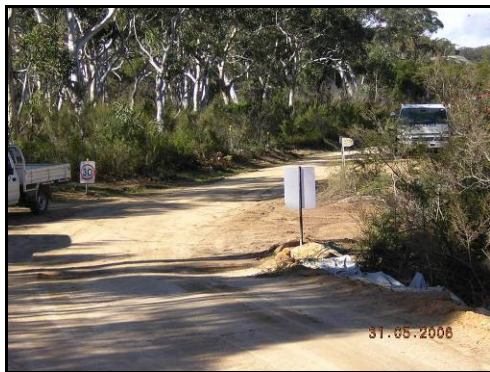
This is an open site containing stone artefacts, located on the south-east bank of Sandy Creek where it is crossed by Fire Trail 6C. The site is immediately adjacent to Sandy Creek, and has been exposed from the construction of the track and transmission line, and subsequent vehicle movements (Plate 7). The site was originally identified by Caryll Sefton in 1996 with the site area estimated to cover a 31 m x 33 m, and details of 12 artefacts recorded at this time. The site was described by Navin Officer in 2000 with 22 stone artefacts noted across an area of 30 m x 24 m, and then during 2005 by Biosis Research with 7 artefacts observed, with all of these noted to be damaged from vehicles using the track (Plate 8). Areas on either side of the track are generally undisturbed and considered to be of moderate to high potential to contain undisturbed archaeological deposit. The site was subject to a Consent to Destroy in 2005 to allow construction of a new bridge as part of upgrade works to Fire Trail 6C.

Plate 7: 52-2-2043 where Fire Trail 6C crosses Sandy Creek.

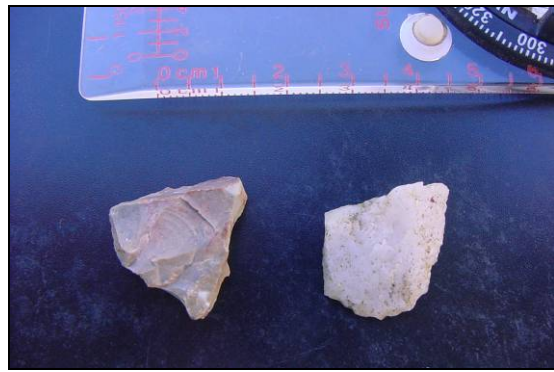
Plate 8:Artefacts at site 52-2-2043

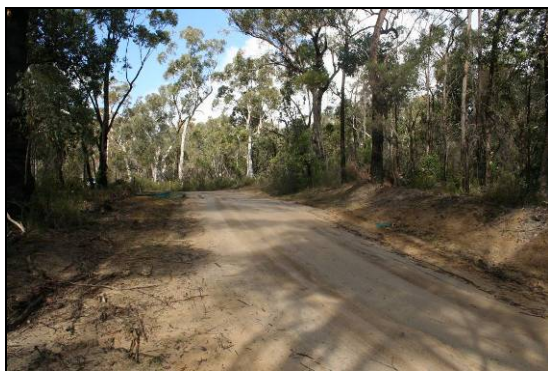
This is an open site containing stone artefacts located where Fire Trail 6C crosses a small gully, approximately 1.5km north of the Sandy Creek crossing and site 52-2-2043 (Plate 9). The site was subject to a Consent to Destroy in 2005 to allow cut and fill upgrade works to Fire Trail 6C. Approximately 10 stone artefacts have been noted at the site, with 6 recorded in detail (Plate 10). Areas adjacent to the fire trail are considered to contain undisturbed areas of archaeological potential. The exposed area of the site is defined by the artefact distribution and track margins, and measures 30 m x 4 m.

Plate 9: Site 52-2-3052 on Fire Trail 6C

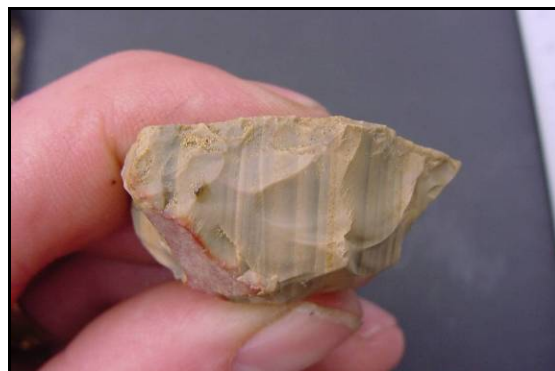
Plate 10: An artefact from site 52-2-3052

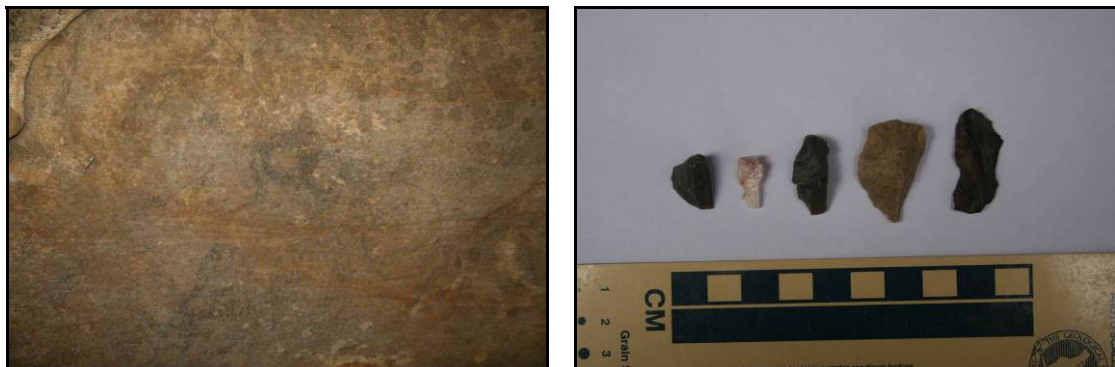
Plate 11: Charcoal anthropomorph with large eyes at site 52-5-273
Plate 12: Stone artefacts located in site 52-5-273

The art within the shelter includes one outline and infill human anthropomorph with large eyes, one charcoal outline and infill indeterminate and one charcoal outline indeterminate (Plate 11).

The deposit in the shelter comprises a dark grey brown sandy loam. A number of smothered quartz pebbles were identified in the drip line. A total of five artefacts were recorded and of which were found in the drip line. This included 1 silcrete flake, 1 silcrete core fragment, 1 broken quartz flake, 1 chert flake fragment and 1 petrified wood flake (Plate 12).

The shelter is mostly dry however there is some water seepage over the lip of the shelter which has caused erosion at the drip line of the shelter, and caused lichen and mould growth on some surfaces of the shelter roof. The art, however, remains in the same condition despite being slightly faded. Since the original time of recorded some surface exfoliation has occurred.

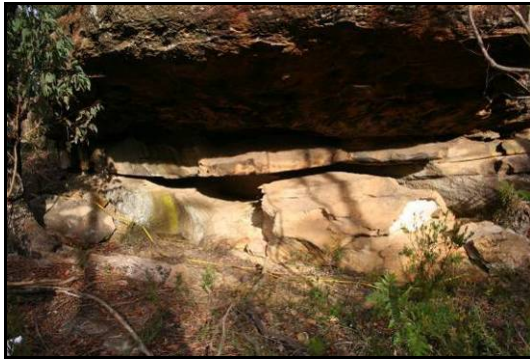
Plate 13: Moderate sandstone overhang at site 52-2-274 **Plate 14:** Charcoal motif at shelter site 52-2-274

The art within the shelter appears to be in the same condition as when it was originally recorded. The shelter is relatively dry, although is exposed to several hours of direct sunlight every day (Plate 13), contributing to the deterioration of the art. No seepage was noted and there are no micro-organisms present on the surface of the art. There are some horizontal bedding planes present at this site and significant exfoliation process adjacent to the art panels.

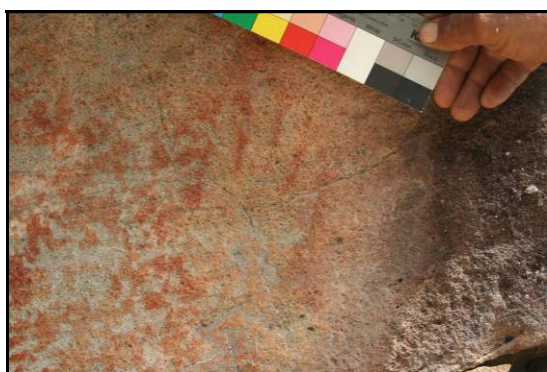
The original recording of this site identified 9 red ochre hand stencils located on the rear wall. All the stencils were adult and 6 were of the left hand wand 3 were of the right hand (Plate 15). The current survey identified one more red ochre hand stencil within the shelter making a total of ten. The current survey also recorded an artefact within the site, a quartz core (Plate 16). The deposit on the shelter floor is yellow sand up to 15 cm deep, deposited from the erosion of the shelter surface.

Plate 15: Red ochre hand stencil in shelter site 52-5-277

The shelter shows no signs of water seepage, and no micro-organisms are present, however, the site is exposed to the elements such as wind erosion and weathering which causes continuous exfoliation. There has been some disturbance by wombats on the floor of the shelter. The art is in poor to fair condition.

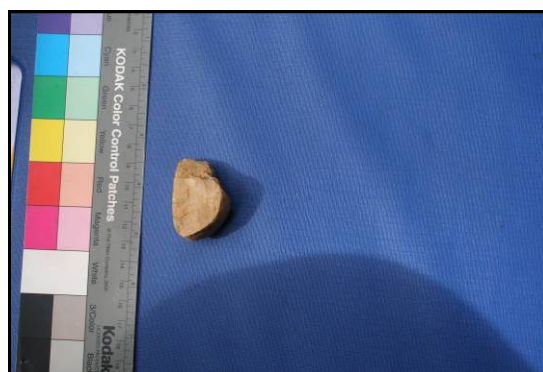
Plate 16: Quartz core artefact located within shelter site 52-5-277

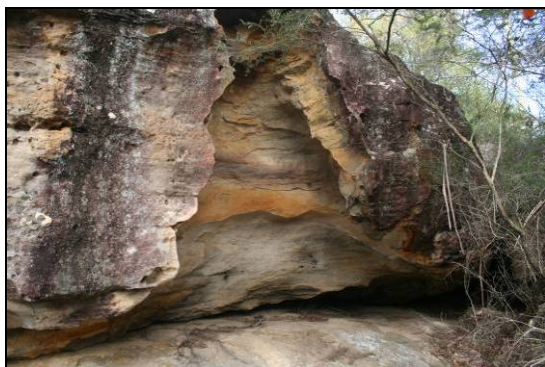
This art shelter site is a small cavernously weathered cavern on the western face of the same sandstone outcrop as 52-2-277. The overhang is situated below the top cliff line on small sandstone outcrop, on the northern edge of the 66kV power line easement that runs from Fire Trail 6C down to the mouth of Sandy Creek. The closest water source to this site is located 200 m away at a tributary of Sandy Creek. The shelter was formed by block fall and cavernous weathering and the sandstone overhang measures 3 m x 2 m x 3 m in size (Plate 17). The shelter has a stone floor with no deposit or living area. The art is located on the rear wall and is one charcoal indeterminate (Plate 18).

Plate 17: Art shelter site 52-5-278

The site is in poor condition. The surface of the shelter has been significantly weathered causing deterioration of the charcoal art. The surface of the shelter has evidence of water leeching, however there are no micro-organisms growing on the surfaces. Ongoing weathering is an additional conservation concern.

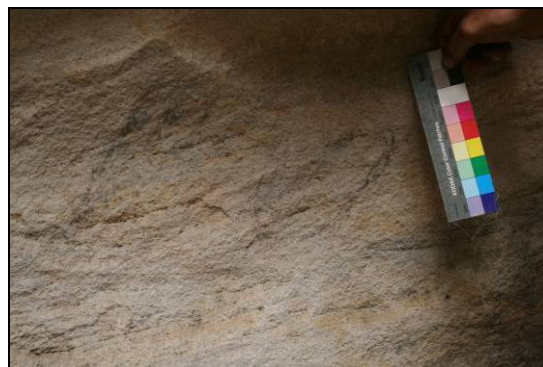
Plate 18: Charcoal motif in shelter site 52-5-278

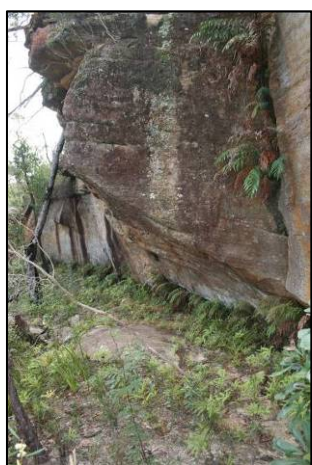
Plate 19: Steep cliff line overhang at site DM 13

No major bedding planes at this section of the cliff line. There is one horizontal plane where the narrow roof meets the top of the cliff line. Major sandstone block fall has occurred at the front of the shelter, reducing the size of the liveable area. No water seepage was evident although the surface of the cliff line does contain some lichen and micro-organism growth. Small ferns are growing from some cracks and in the drip line along the front of the shelter.

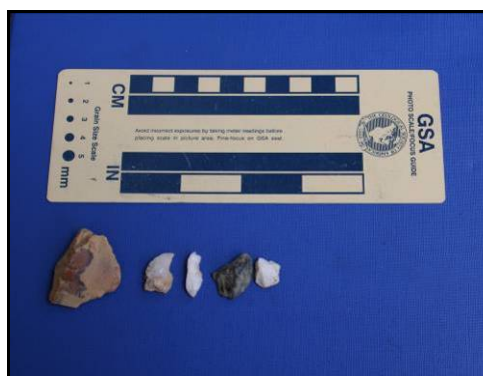
Plate 20: Stone artefacts recorded at site DM 13

The deposit within the living area consists of yellow brown sand that is quite coarse in texture. It is estimated to be between 30 cm and 40 cm deep across the living floor. The surface of the floor has been partly disturbed by wombat diggings, as there is a wombat hole situated at the centre base of the cliff line. A small number of stone artefacts were exposed on the spoil from the wombat hole. These included one silcrete scraper, 3 quartz flakes and one petrified wood flake fragment (Plate 20).

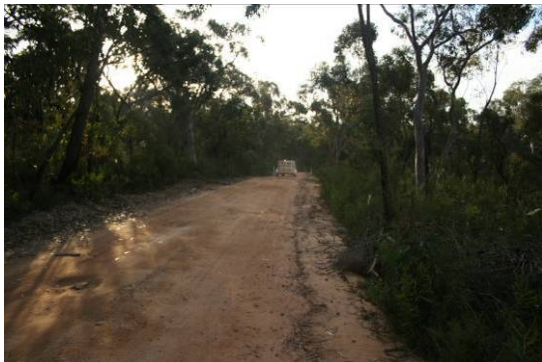
This isolated artefact occurrence is situated in the centre of Fire Trail 6C, north of the intersection of Fire Trail 6C and the access track to the 66kV overhead power line, east of the site (Plate 21). The site comprises a single broken mudstone artefact (Plate 22).

Plate 21: View north along Fire Trail 6C across site DM14

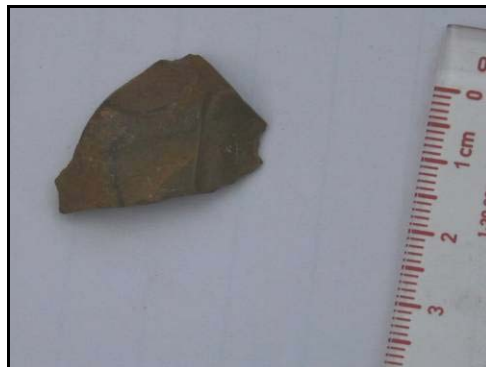
Plate 22: Single mudstone flake at site DM 14

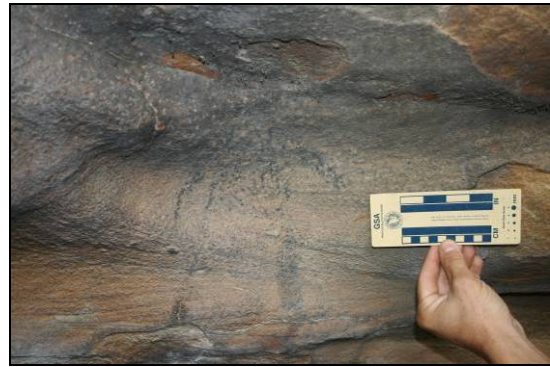
The art comprises a single solid charcoal anthropomorphic or possibly bat figure on a small panel measuring 30 cm x 50 cm (Plate 24). It is situated at the western end of the overhang and has been preserved by a thin silica skin. It is also one of the only remaining areas across the surface of the overhang that has not been exfoliated.

Plate 24: Single solid charcoal motif at site DM 15

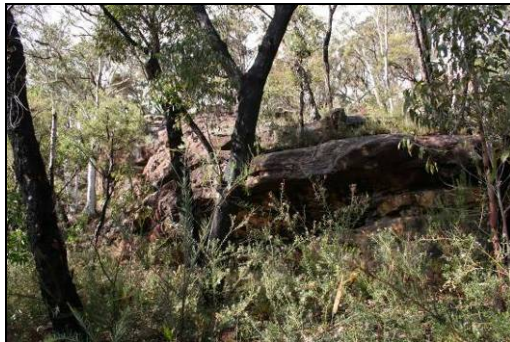
Plate 25: Small overhang at site DM 20, southeast

The art comprises charcoal outline and infill indeterminate motifs across the rear wall of the small cavern (Plate 25), and 1 anthropomorph on the edge of the cavern (Plate 26). The majority of the art cannot be distinguished.

The motifs are in poor condition due to extensive water seepage, leeching and micro-organism growth. The small cavern in which they are situated is also subject to continuous weathering processes, although no major cracks or bedding planes are present within the small cavern. Some horizontal bedding planes are present in the larger overhang in which the small cavern is located. Overall, the site is in a degraded condition.

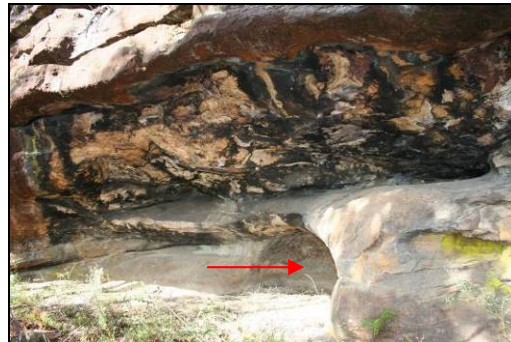
Plate 26: Lower cavern contains art at site DM 20

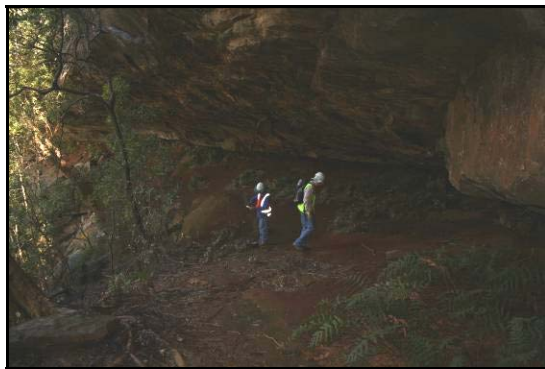
This site is a shelter with archaeological deposit, located directly below the Sandy Creek waterfall, near where Fire Road 6C crosses Sandy Creek. The shelter measures 80 m x 30 m x 8m and has been formed by block fall on a large scale, with most of the shelter floor forming a steep slope and being strewn with very large angular boulders. However, the western end of the shelter contains approximately 20 m of reasonably flat floor, which has a well developed, though very damp deposit, of red soil (Plate 27). There were 6 artefacts, including cores and a retouched flake, located in the drip line and eroded parts of the deposit (Plate 28).

Plate 27: Archaeological deposit at DM23

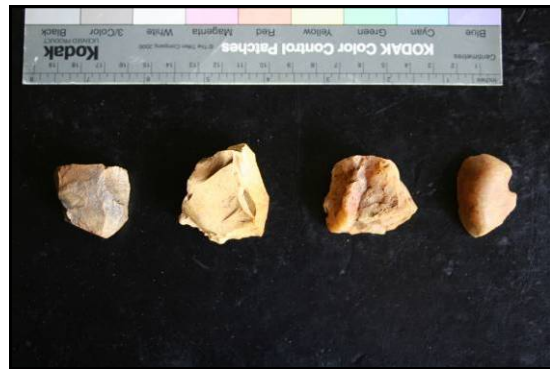
Plate 28: Artefacts at DM23
