Dendrobium Colliery Area 3A, Longwall 6

**END OF PANEL REPORT
FOR LONGWALL 6
AT DENDROBIUM COLLIERY**

July 2011

Comur Consulting Pty Ltd

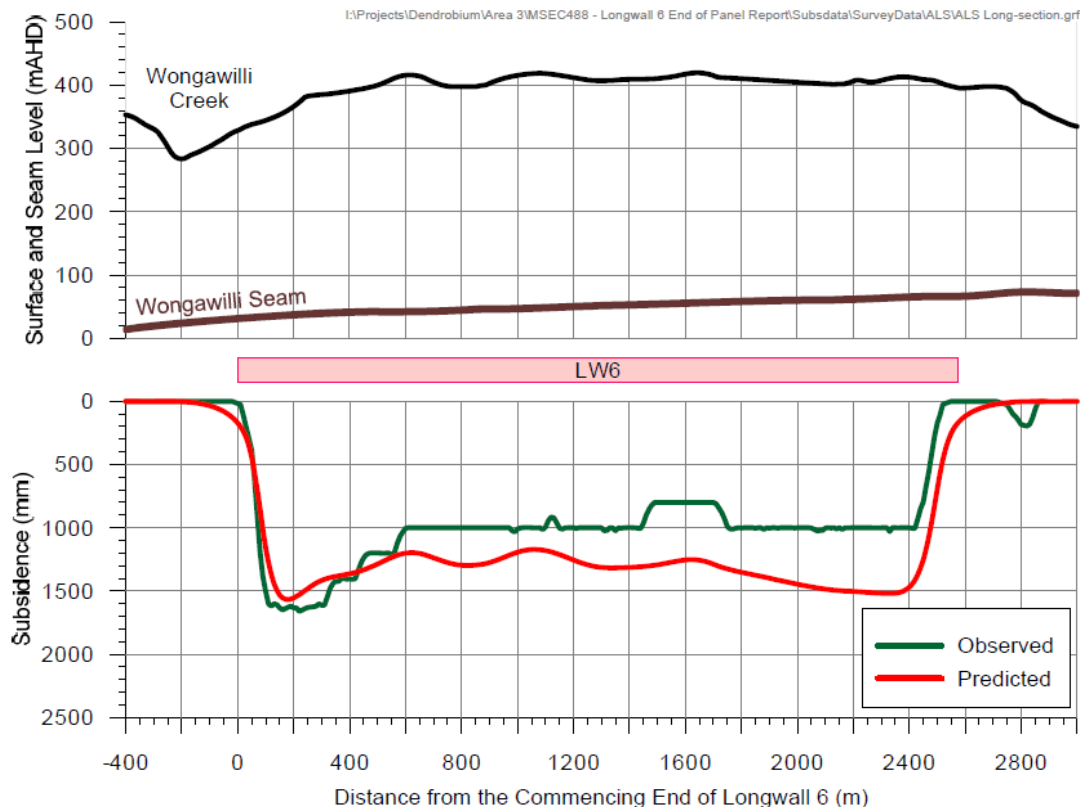
Figure 3.2 - Observed Changes in Surface Level and Predicted Subsidence along Long-section 1

It can be seen from the above figure, that the observed changes in surface level along Long-section 1 are generally similar to or slightly less than those predicted above Longwall 6. The observed changes in surface level are slightly greater than those predicted, in some locations, however, these differences are generally within the order of accuracy of the ALS results.

The maximum observed incremental changes in surface level at Cross-sections 1, 2 and 3 were less than the maximum predicted total subsidence movements. The locations of the maximum observed changes in surface level and the maximum predicted subsidence were in similar locations, near the longwall centreline, which is expected for a first panel in a series.

The profiles of the observed total changes in surface level are more localised above the extracted longwall, whereas the predicted subsidence profiles extend further outside the edges of the longwall. It can be inferred from the steepness of the profiles in the above figure, that the maximum observed tilts at these cross-sections are reasonably similar to the maximum predicted tilts in these locations.

The profiles of the observed changes in surface level along one long-section and three cross-sections have been determined from the results of the ALS, the locations of which are shown in **Attachment A** (Drawing No. MSEC438-07). The profile of the predicted and observed incremental changes in surface level along Long-section 1, due to the extraction of Longwall 6, is provided in **Figure 3.2**.

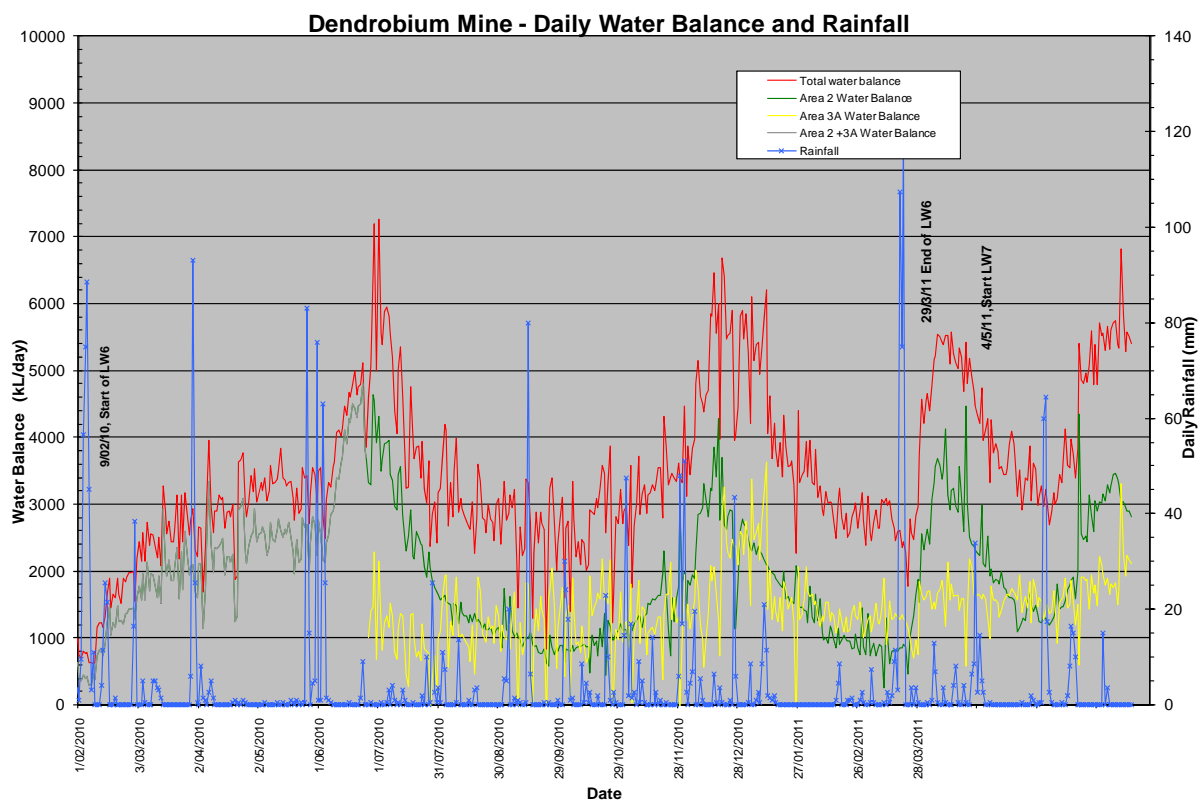
Figure 4.2 – Dendrobium Mine Daily Water Balance and Rainfall

Monitoring for a discrete Area 3A water balance was established on 26 June 2010. The Area 3A water balance determines the groundwater inflow into Area 3A from all operational panels (longwall & development). **Figure 4.2** shows the Area 2 and 3A Balance in relation to the Total Mine Balance.

Mine inflow to Area 3A during Longwall 6 extraction averaged 1.3 ML/day with standard deviation 0.6 ML/day. Although this was much lower than the predicted rate of 3-4 ML/day, the maximum Area 3A inflow of 3.6 ML/day (on 11 January 2011) fell within the predicted range. The low inflow rates support the model-based contention that there will be negligible loss of water from the Cordeaux Reservoir to Area 3A.

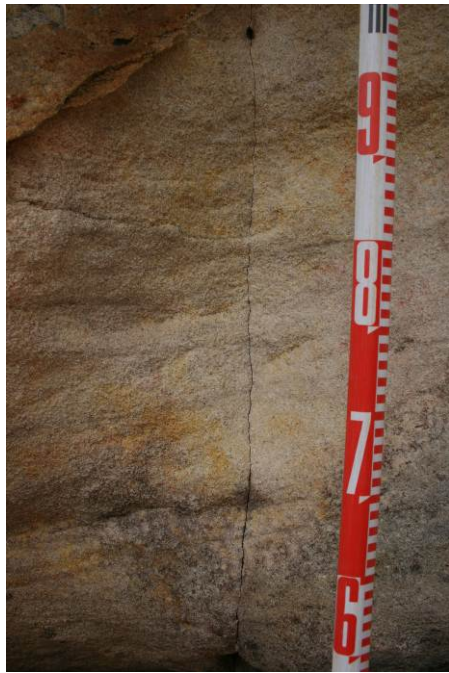
Monitoring undertaken 2 February 2011 at rock shelter SCR25 identified the slight expansion of jointing near the main art panel as shown in **Figure 5.7**. This is considered to be very minor in nature and unlikely to lead to secondary impacts such as water seepage or rock falls. The art at the site has not been impacted, though there is potential for the cracking to speed up natural exfoliation processes. These impacts were in line with predictions.

Baseline record - Vertical joint plane prior to longwall mining, located below the main art panel

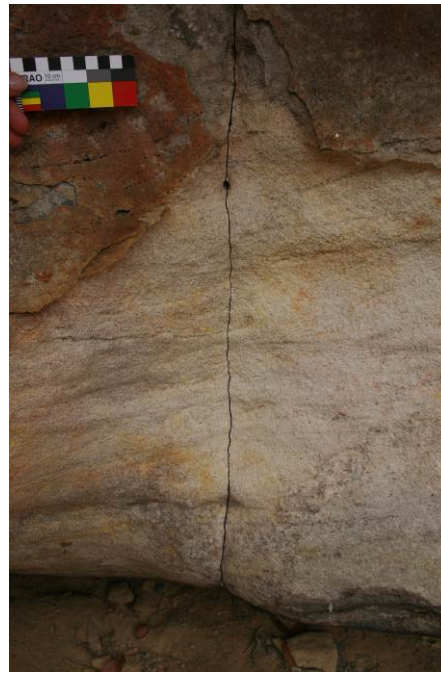
Figure 5.7 - Photographs of vertical joint prior to and post Longwall 6 mining in SCR26

Post Longwall 6 record (2 February) - Vertical joint plane has begun to separate

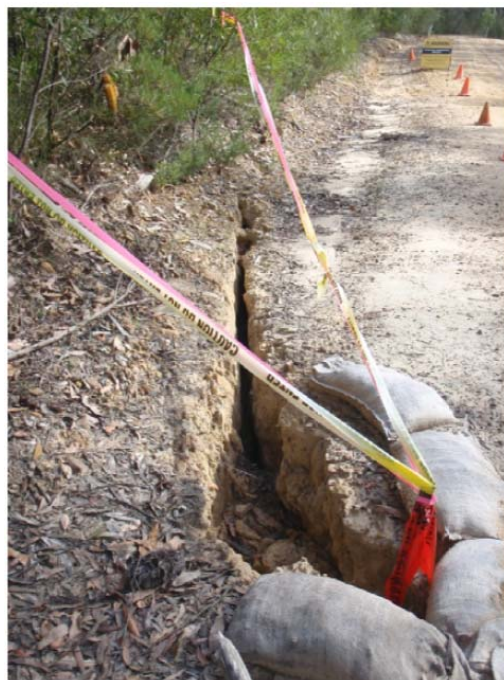
Minor fracturing and soil cracking occurred along some of the fire roads in the vicinity of Longwall 6. Discontinuous hairline and small cracks were identified on Fire Road 6C, 6F and 6K at eight locations.

Left: Soil Crack DA3_62 looking north with sediment control and safety precautions.

Given that Fire Road 6C is a major road within the catchment area, approval to carry out remediation work on surface cracking was obtained from the Sydney Catchment Authority. Remediation works were undertaken successfully on surface crack DA3Longwall 6_62 as discussed in **Section 7**.

- placement of temporary sediment control and safety precautions;
- removal of the temporary barricade tape and sandbags;
- infilling the soil crack by hand with locally sourced sandstone and sediment from a nearby stockpile;
- packing and compacting fill into the crack in small quantities;
- continuing this process until the crack was filled.

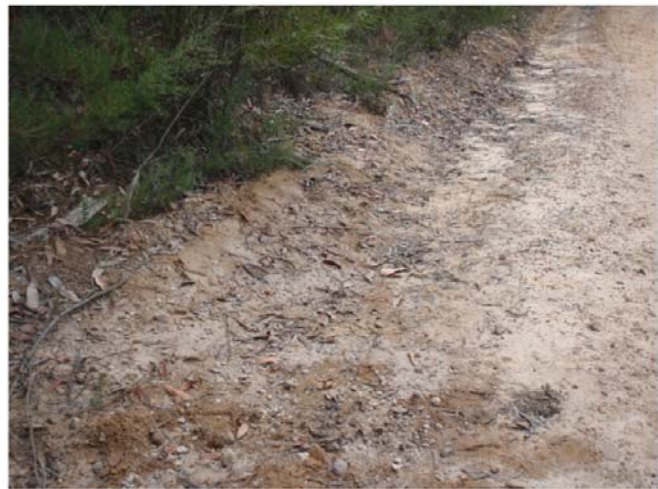
Figure 7.1 Results of rehabilitation of soil cracking in Fire Road 6C

Below: DA3_62 looking north following rehabilitation
