## **F.2 2004 Soil Survey – Poitrel and Red Mountain Mining Leases**

### **F.2.1 Introduction**

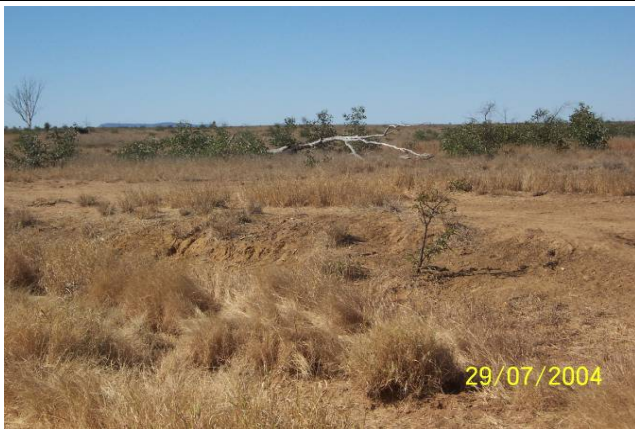
### Surface Features: Site 41

Soil Type	A2

Concept	Sandy duplex alluvial plain with mixed poplar box scrub.	
AMG Reference	631239 mE 7554582 mN	
Site No	41	
Australian Soil Classification	Brown Sodosol	
Landform Element	Drainage line	
Landform Pattern	199 m Flat alluvial plain	
Slope %	<0.5%	
Microrelief	none.	
Surface condition	Sandy, non cracking, hardsetting, no stone or rock	
Land Condition	Quite bare and eroding in drainage line, stable above	
Land Use	Being grazed by beef cattle	
Major Vegetation Form and Type	Mostly cleared with remnant Blackbutt, Bauhinia, Leichhardt bean, Poplar Box and Brigalow. Buffel pasture 40% cover	
Samples for analysis	0-10, 50-60 cm	
<p>Land Suitability Summary.</p> <p>Stocking rates recommended by Bourne &amp; Tuck (1993) for cleared pasture as ha / adult equivalent beast (AE) for long term sustainability.</p>		<p><b>Cropping</b> – Class 5 unsuitable with major limiting factor(s) moisture availability (5).</p> <p><b>Grazing</b> – Class 4 suitable with major limitations from moisture (3), fertility (3). Stocking rate 15 ha/AE</p>

This soil type occupies the floodplain and channel of New Chum Creek. The soil is generally a hard setting sandy loam with a bleached A2 over hard, coarse structured medium yellow clay often heavily mottled. Poplar Box mixed woodlands predominate with occasional associated Brigalow. It occurs on 0 - 2% slopes, is susceptible to occasional flooding and supports generally sparser levels of buffel than found elsewhere on the site.

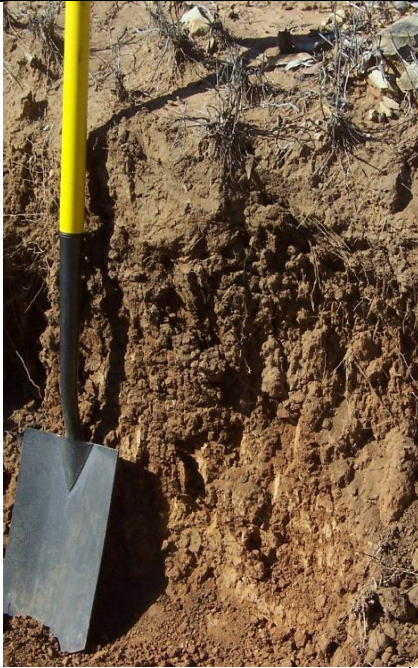
### Soil Profile: Site 41

Horizon	Depth	Description
	A11	0-15	Dark Brown 10YR4/3, sandy loam, no mottles or coarse fragments, loose and massive. Field pH 6.5, clear to;
	B21	15-45	Brown 7.5YR5/6, medium clay (sandy), field pH 7.0, some yellow mottles and fine sandstone gravel (<10%), very hard angular blocky. Gradual to;
	B22	45 –100+	Brown 7.5YR4/4, medium clay (sandy), field pH 8.0, mottles increasing with calcium carbonate nodules and gravel, very hard angular blocky.
	Recommended Topsoil Strip Depth		10 -15 cm
	Preferred Rehabilitation Use		Flat sites only due to high erosion potential. Place > 25 cm depth
	0.0m		
0.1m			
0.2m			
0.3m			
0.4m			
0.5m			
0.6m			
0.7m			
0.8m

Typically the soil can be stripped between 100 mm to 150mm, the stripping should not extend into the bleached layer (if present) and or the clayey B horizon. If stripped, the soil will be useful on rehabilitation of level surfaces such as dump tops.

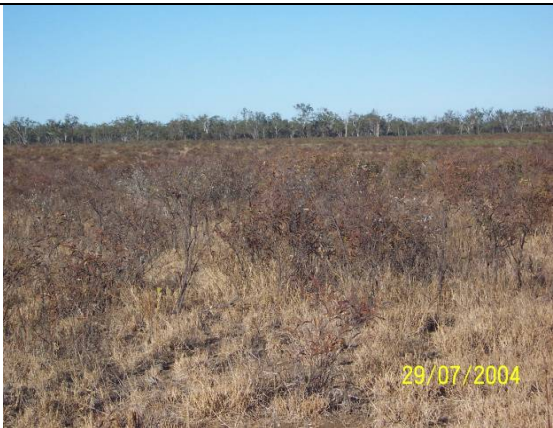
#### Surface Features: Site 178

Soil Type	B4

Concept	Deep. Well structured scrub soils with soft granular mulch with Brigalow regrowth	
AMG Reference:	630032 mE 7561875 mN	
Site No	178	
Australian Soil Classification	Black Vertosol	
Landform Element	Upper slope	
Landform Pattern	RL 239 m. Gently undulating plains.	
Slope %	1	
Microrelief :	None.	
Surface condition	Soft, granular mulch over cracking dark clay. Some lateritic gravel on mounds (< 5%).	
Land Condition	Stable. Appears to have cropping potential. Extensive Brigalow regrowth.	
Land Use	Being grazed by beef cattle	
Major Vegetation Form and Type	Completely cleared with strong regrowth of Brigalow up to 1.5 m high. Strong cover of ragweed and buffel.	
Samples for analysis	: 0-10, 40-50, 80-90 cm	
Land Suitability Summary. Stocking rates recommended by Bourne & Tuck (1993) for cleared pasture as ha / adult equivalent beast (AE) for long term sustainability.	<p><b>Cropping</b> – Class 4 suitable for occasional cropping, significant moisture (climatic) limitation for sustainable cropping. Could be used for opportunistic forage or cropping.</p> <p><b>Grazing</b> - Class 2 excellent grazing land (if Brigalow regrowth cleared and pasture established). Stocking rate - 5 ha/AE</p>

This classic black Brigalow soil unit occupies gently sloping Brigalow regrowth plains between drainage lines on the western side of the lease area. The soil is friable and soft underfoot and is a self-mulching black cracking clay. Nutrient levels are reasonable except phosphorus, which is low.

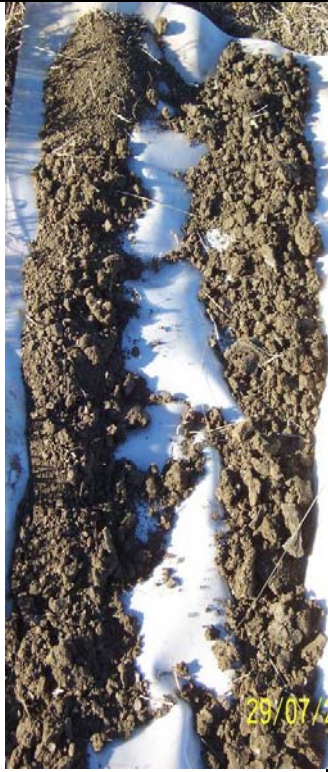
**Soil Profile: Site 178**

0.7m	Horizon	Depth	Description
			Surface	0	Soft, friable Strong granular self mulching surface with carbonate nodules. Cracking with a few coarse fragments.

0.8m	A1	0-5	Carbonate nodules, field pH 7.0, dark greyish brown 10YR4/2, Light medium clay, strong subangular blocky, firm, clear to;
		0.9m	B21	5-35	Strong subangular blocky structure, Carb. Nodules, pH 7.5, very dark greyish brown 10YR3/2, no mottles, well drained, light med clay.

1.0m	B22	35-80	Strong subangular blocky, increasing carbonate nodules, field pH 8.0, Dark brown 10YR3/3, no mottles, medium heavy clay.
		1.1m	B23	80-120+	As for B22 except becoming lighter colour, Brown 10YR4/3.

1.2m	Recommended Topsoil Strip Depth		40 cm
			Preferred Rehabilitation Application		A quality black soil. However these soils are prone to droughting and are difficult to re-establish grasses and trees – except in very good seasons. Use on flat or gently sloping sites only as the soil may take several seasons to establish vegetation and re ripping and seeding may well be required. Place > 25 cm.

The entire soil profile could be used in mine site rehabilitation if required although care should be taken to test for salt which may occur at depth. Accordingly, a 300 mm overall tripping depth is recommended due to the risk of saline / sodic subsoils.
