End of Panel Report

December 2011

**Illawarra Coal Environmental Field
Team**

West Cliff Mine Longwall 34

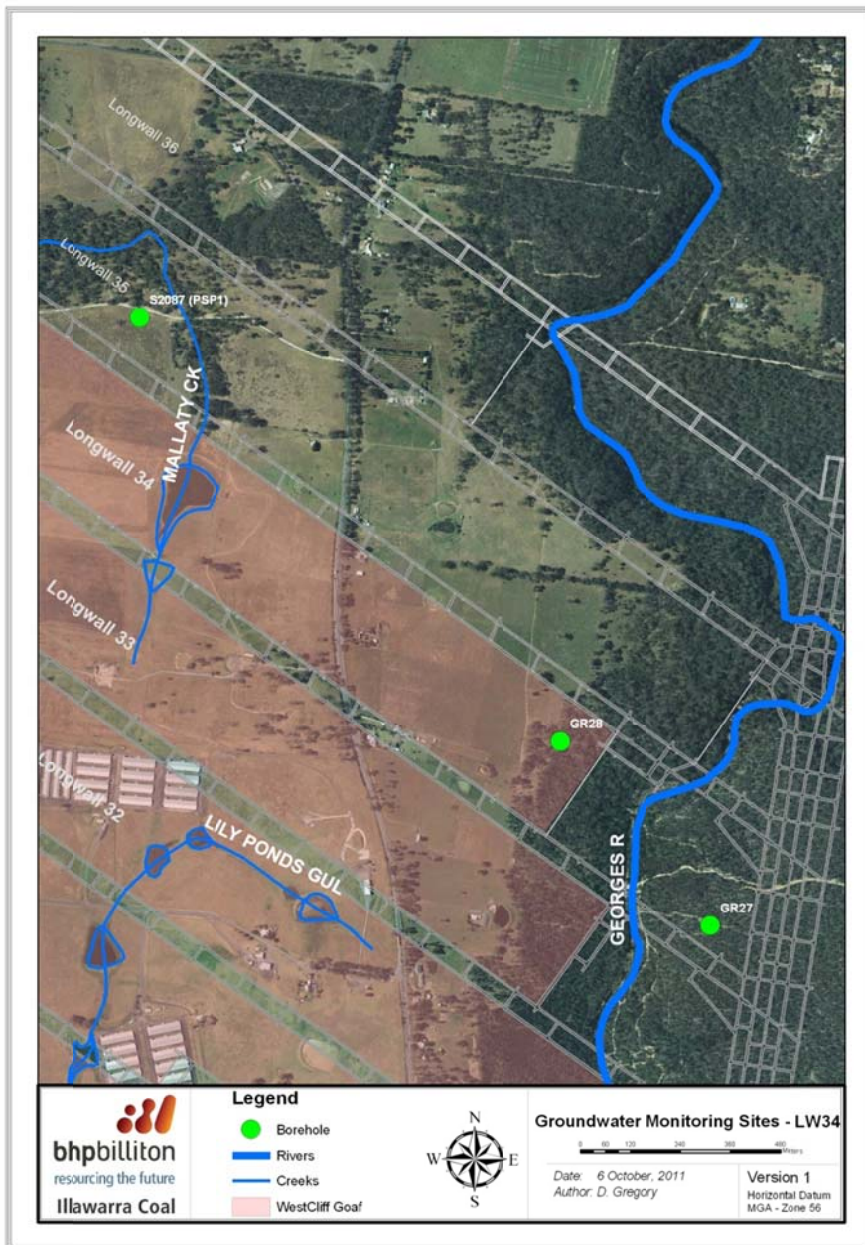
Figure 10: Locations of Boreholes GR27, GR28 and S2087 (PSP1) in relation to Longwall 34.

Boreholes GR27, GR28 and S2087 (PSP1) were monitored during the extraction of Longwall 34 as required by the SMP. The location of these boreholes is displayed in Figure 10. The boreholes are screened in a section of strata equivalent to the base of the river in that location. Previous longwall extraction in West Cliff Area 5 has indicated that groundwater levels directly over or adjacent to goaf areas can reduce as a result of extraction.

Borehole GR27 water levels have remained relatively stable with no water level reduction associated with Longwall 34 extraction (**Error! Reference source not found.**). Borehole GR28 recorded a temporary decrease in water level toward the end of Longwall 34 extraction. Since the initial reduction in water levels in GR28 the water level has responded to recharge rainfall events. Water level rises were recorded after rain events on 25 and 26 September 2011 and 3 October 2011 (**Error! Reference source not found.**).
