# BULLI SEAM OPERATIONS

## SECTION 6 REHABILITATION AND MINE CLOSURE

## 6 REHABILITATION AND MINE CLOSURE

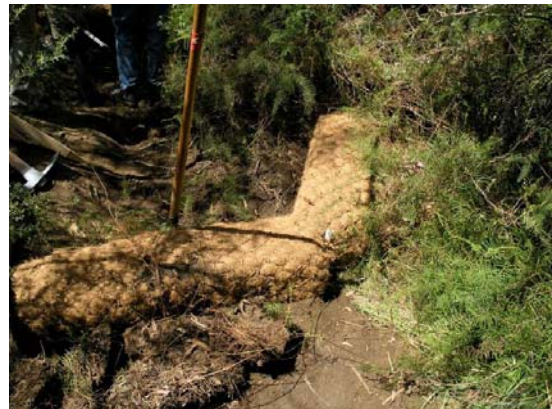
**Plate 6-1 - Square Coir Logs for Knick Point Control**

Tilting of sufficient magnitude can re-concentrate runoff leading to scour and erosion or alter water distribution in parts of a swamp. Coir log dams can be installed at knick points, such as those shown in Plate 6-1. The square coir logs used for the construction of these small dams were developed specifically for swamp rehabilitation and have been successfully used during a number of swamp rehabilitation programmes of recent years in the Blue Mountains and Snowy Mountains (Good *et al.*, unpublished).

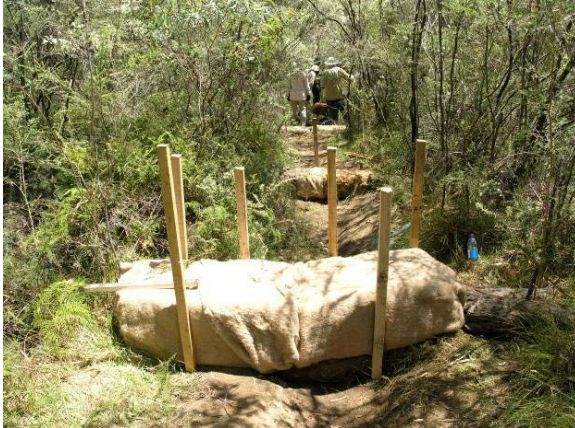
**Plate 6-2 - Small Coir Log Dams Constructed at Intervals along an Incised Swamp with Jute Wrapping**

A trench is cut into the swamp soils such that the first layer of coir logs sits on the underlying substrate or the top of the first coir log is at ground level. The coir logs are held in place by wooden stakes and bound together with wire. The coir log dam slows water flows, allowing siltation behind the log dam (Good *et al.*, unpublished). The small coir log dams are constructed at intervals down the erosion channel. Where increased filtering of flows is required, the coir logs can be wrapped in jute fibre matting as shown in Plate 6-2.

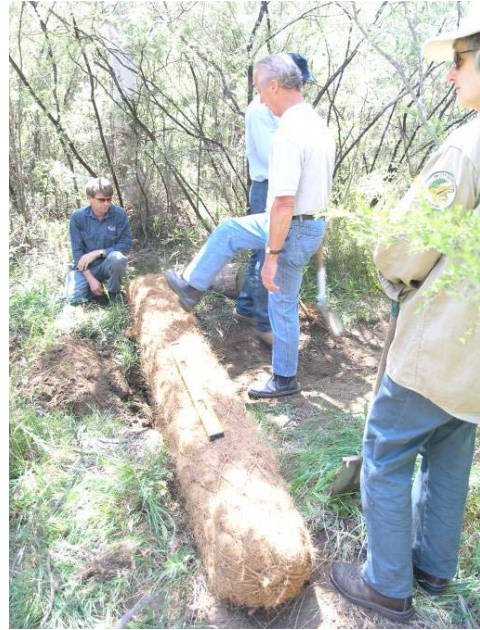
**Plate 6-3 - Round Coir Logs Installed to Spread Water**

The maintenance of the swamp moisture regime can also be enhanced by additional water spreading techniques, involving long lengths of coir logs and hessian 'sausages' linked together across the contour such that water flow builds up behind them then slowly seeps through the water spreaders (Good *et al.*, unpublished). The water spreaders can be positioned as required within shallow trenches within a swamp (Plate 6-3).

Erosion control and water spreading involves soft-engineering materials that would contribute to and function as part of the swamp system but would eventually degrade (totally biodegradable) and become integrated into the soil/organic matter complex of the swamps (Good *et al.*, unpublished).
